HERZENBERG DAM

NJ 00146

PHASE 1 INSPECTION REPORT
NATIONAL DAM SAFETY PROGRAM

REPT. NO: DAEN/NAP-53842/NJ00146-81/07
JULY 1981

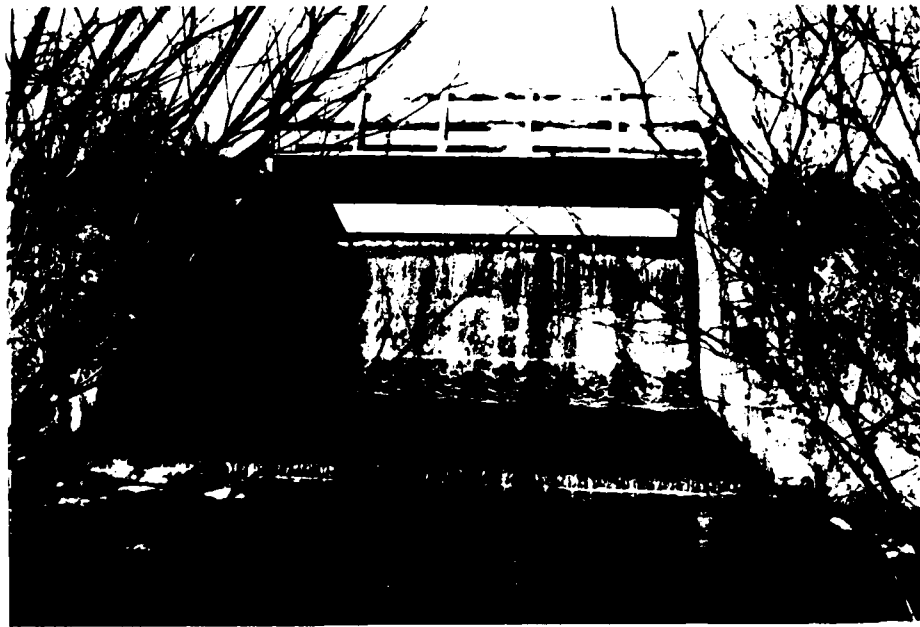
The discharge capacity of the principal spillway has been reduced by the installation of a 12-inch-high flashboard on the crest of the ogee weir and the construction of a girder-supported wood plank bridge over the crest. The bridge soffit extends 8 inches down into the spillway, reducing the clear opening from 4 feet by 24.5 feet to 2.33 feet by 24.5 feet. A spalled line 4 to 8 inches wide and up to 1 inch deep has developed along the entire length of the crest where the discharge over the flashboard hits the weir. Another, lighter line of spalling was noted about one-third of way down the spillway apron and sporadic light spalling and efflorescence were observed on both wingwalls. Light seepage was noted emanating from a lightly spalled area about midway down the right downstream wingwall. The right wingwalls are both displaced one-half inch from the sidewall toward the spillway channel, and light erosion and undercutting were observed at the toe of the left downstream wingwall.

Principal Spillway

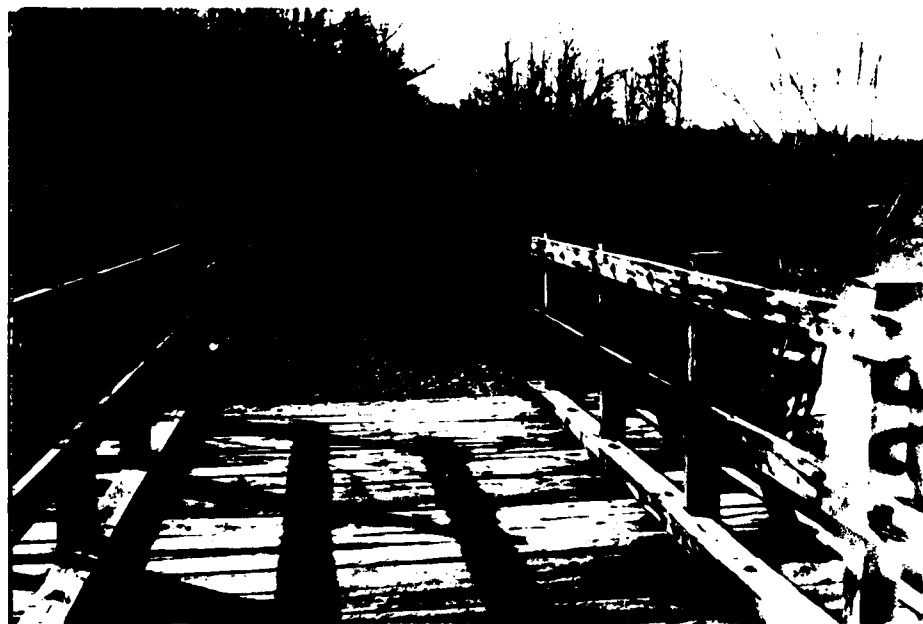
The auxiliary spillway has a thick grass cover with very light sporadic brush noted on the downstream slope. However, a gravel road has been constructed from the right abutment across the control section to the primary spillway. The road embankment, which is 2 to 3 feet high, completely and effectively seals the channel and precludes its use as a spillway.

View of Road Obstructing Auxiliary Spillway

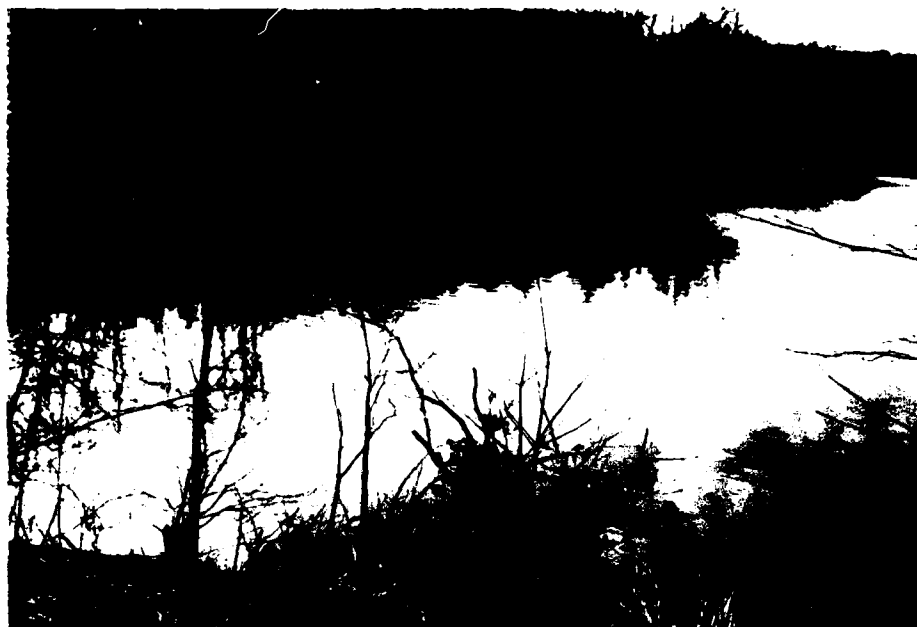
Presently, there is no formal maintenance performed on the dam. The brush and sapling growth on the slopes of the embankment indicate that there has been little maintenance performed in that area for several years. However, the crest of the dam is in good condition and exhibits signs of recent grading and maintenance.

March, 1981
Crest of Dam Looking West
